UNITED STATES ENVIRONMENTAL PROTECTION AGENCY

Subject: September 24, 2015 EPA Compliance Evaluation Inspection at Ex. 6.  
Ex. 6. (Personal Privacy) Swine Farm ILA000115

**CWA COMPLIANCE EVALUATION INSPECTION REPORT**  
**U.S. ENVIRONMENTAL PROTECTION AGENCY, REGION 5**

Compliance Evaluation Inspection – Oversight Inspection

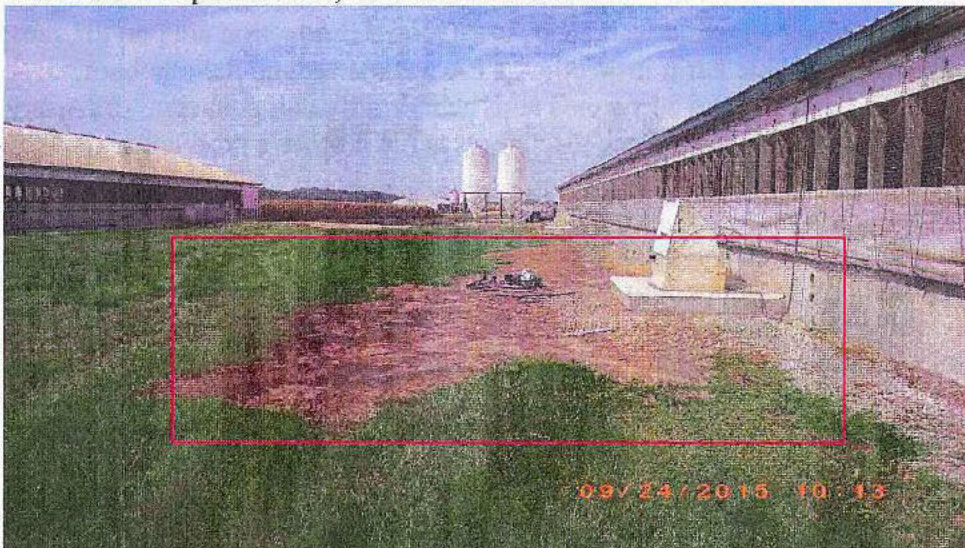
Photo: RIMG0183

Description: Between the northern barn and middle barn. Area around the fan was denuded (as shown in the outlined area in red).

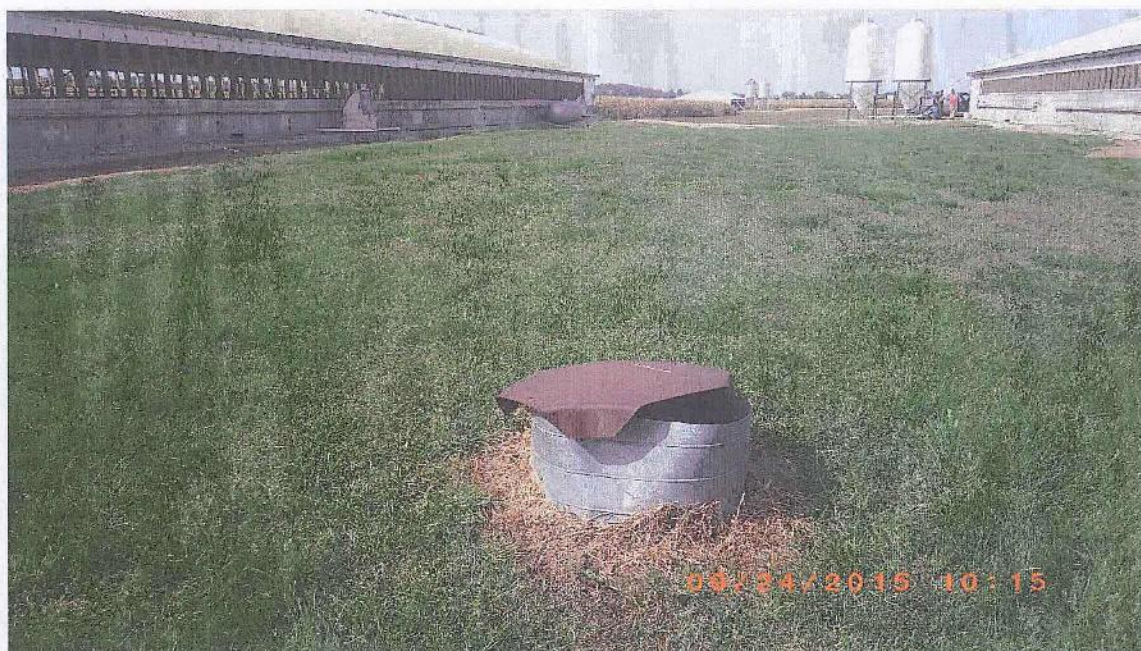
Photo: RIMG0184

Description: Storm water drain between northern barn and middle barn on the east side of the production area.

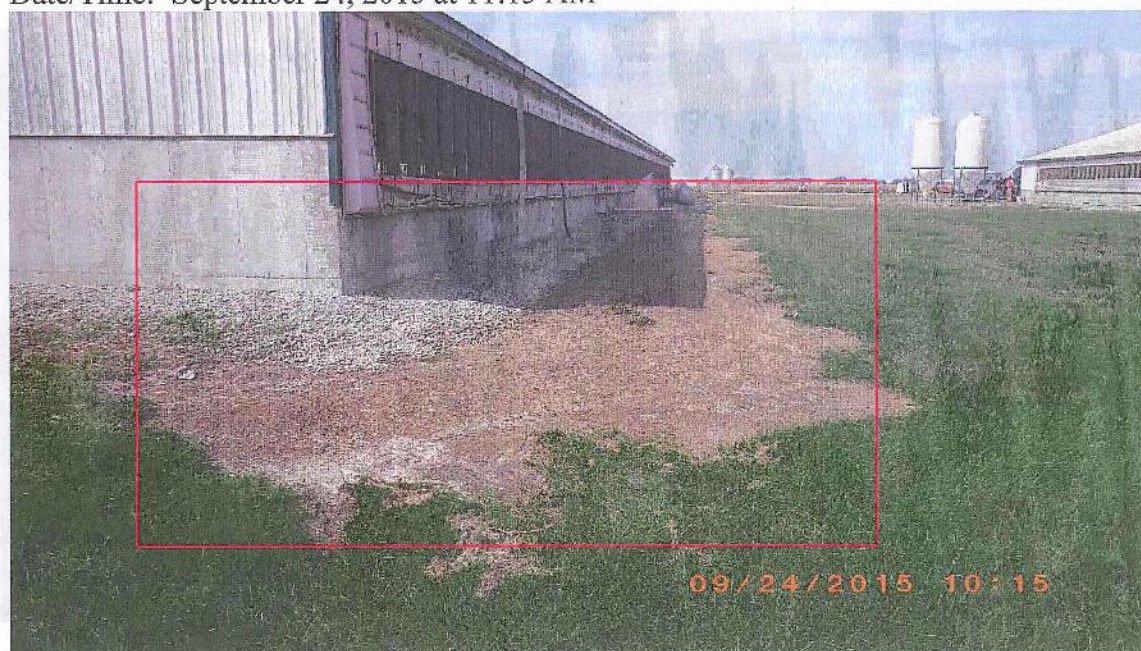
Photo: RIMG0185

Description: Northeast corner of the middle barn was denuded (area outlined in red).

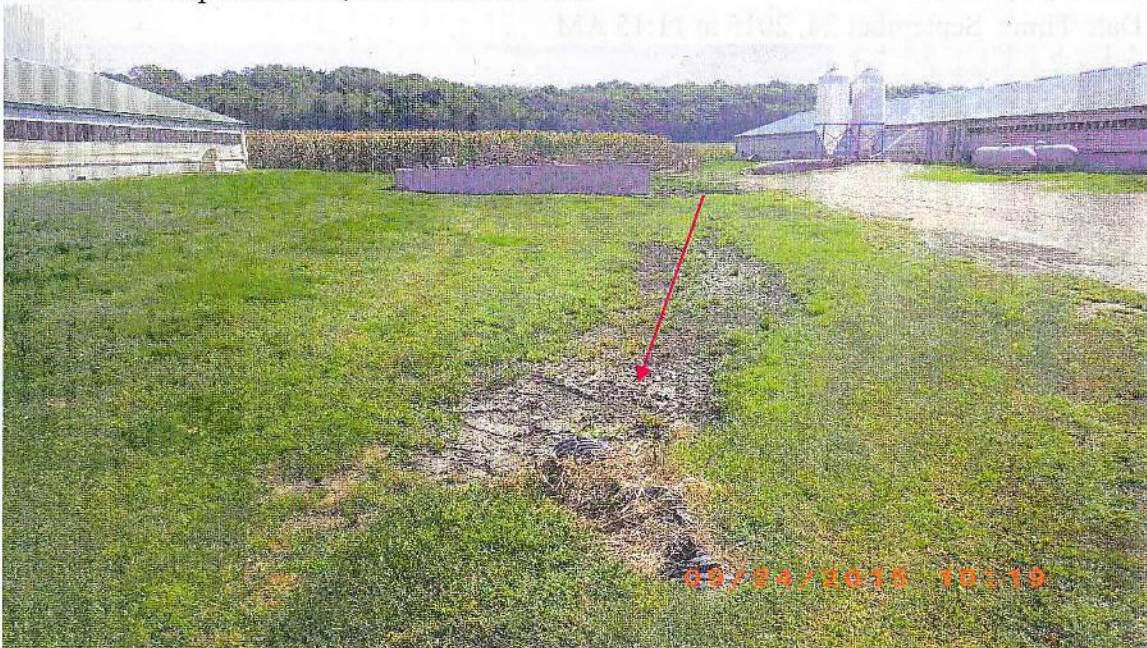
Photo: RIMG0187

During the inspection, EPA observed a denuded, burnt vegetation pathway leading from mortality compost pile to the storm water culvert between the middle barn and the southern barn. A precipitation event could cause the leachate from the mortality compost bunker to flow west into the storm water culvert between the barns and outlet into the corn field. EPA did not observe any nearby waterways due to the crops still being on the field.

Between the middle and southern barns was the mortality compost bunker which had no containment and no roof to prevent precipitation from coming into contact with the mortality compost piles. At the time of the inspection, EPA observed a burned and denuded pathway from the mortality compost piles leading to the storm water culvert inlet. At the time of the inspection, there was no discharge occurring. EPA did observe the culvert outlet which was at the edge of the land application field that had evidence of nutrient build-up. Due to the crops being on the field, EPA did not observe a nearby surface waterway for these nutrients to discharge into.

Description: Between middle and southern barns denuded and burnt vegetation caused by the runoff from the mortality compost bunkers between the buildings (arrow showing direction of flow into storm water culvert).

EPA recommends better housekeeping and management of the mortality compost piles, so that the compost leachate does not make it into the culvert inlet between the middle and southern barns.

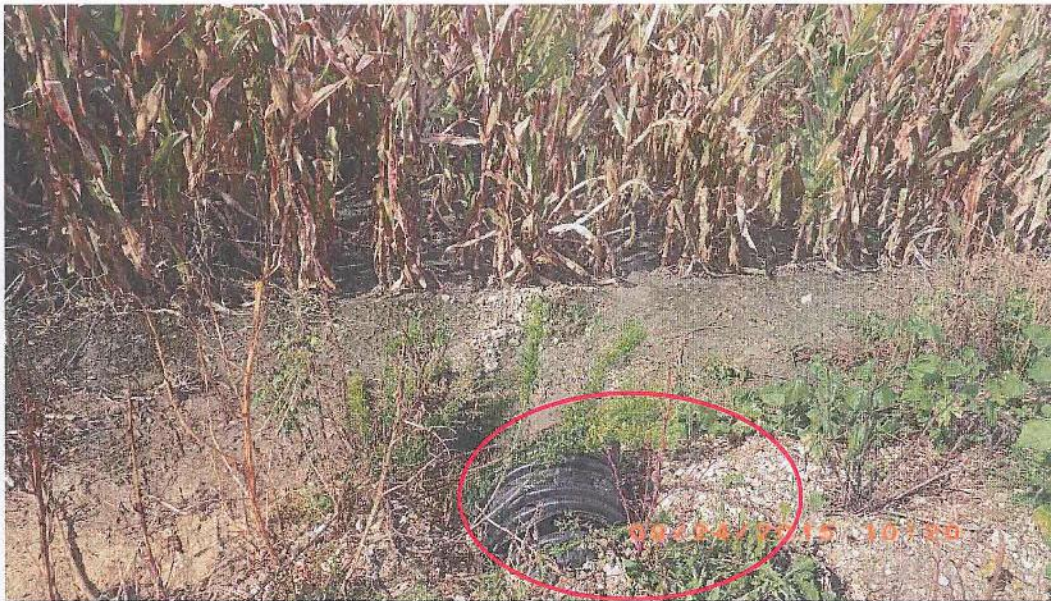
Photo: RIMG0188

Description: Culvert outlet from culvert inlet between middle and southern barns. The culvert inlet is designed to remove clean water from the production area site. No flow was coming out at the time of the inspection. However, nutrient buildup appears around the culvert outlet.

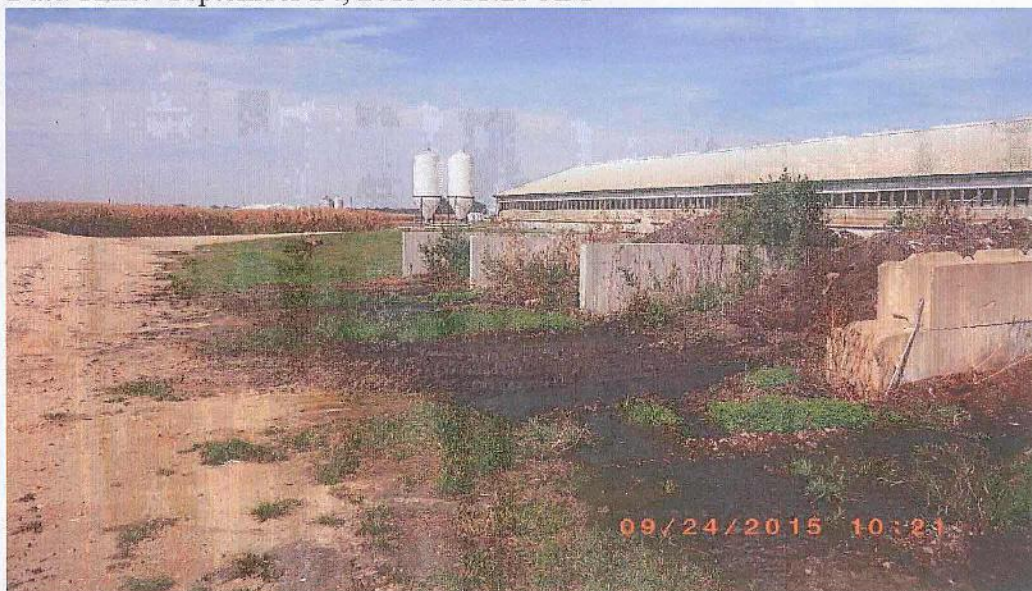
Photo: RIMG0189

Description: Mortality compost bunker between middle and southern barns. No containment. When precipitation comes into contact with the mortality compost pile, it could flow west into the storm water culvert between the middle and southern barns.

Mortality compost bunker did not have containment for the leachate coming off of the mortality compost pile.

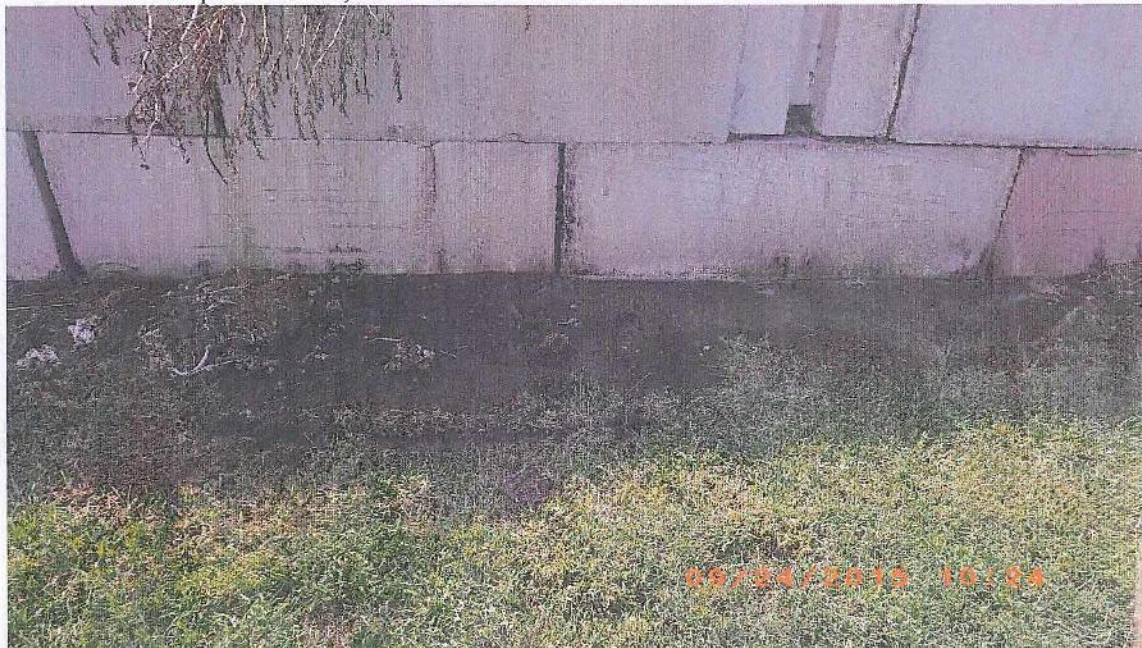
Photo: RIMG0193

Description: Leachate residue from mortality compost bunker seeping through concrete blocks of the mortality compost bunker.

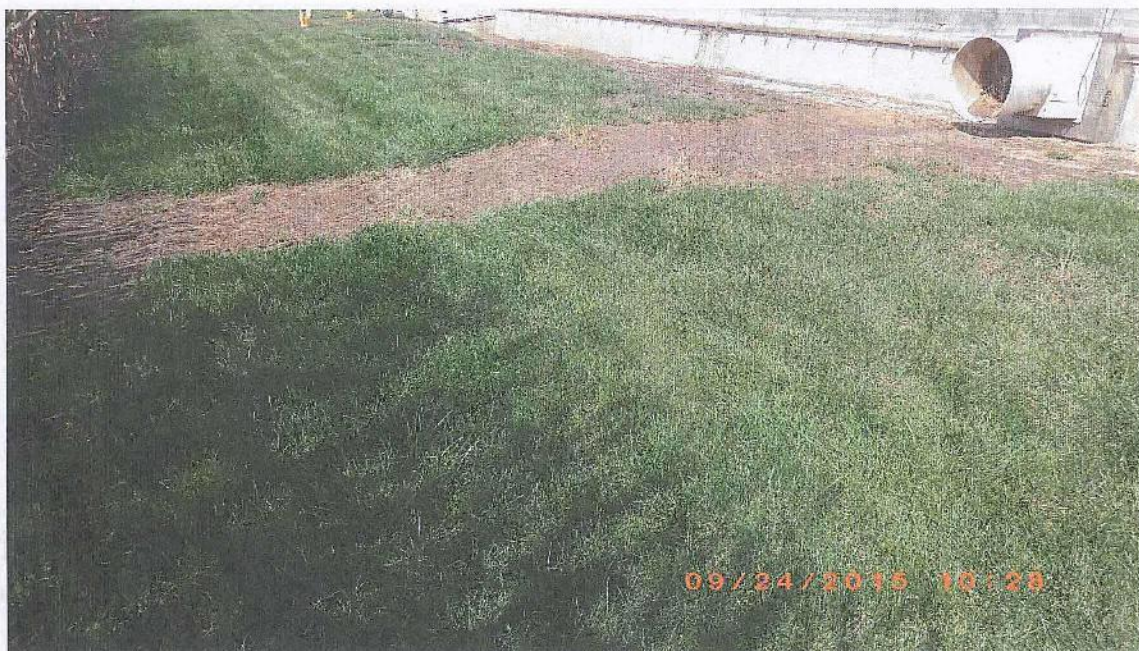
Photo: RIMG0196

Barn fans contributed to denuded areas and feed was on the ground under and around the fans. The facility had no containment to collect the feed from the fan blowouts. EPA did not observe any of the feed on the ground discharging or any denuded or burnt vegetation leading into a surface water at the time of the inspection.

Description: Denuded vegetation underneath and in blow out pathway from southern barn fan on the south side of southern barn.

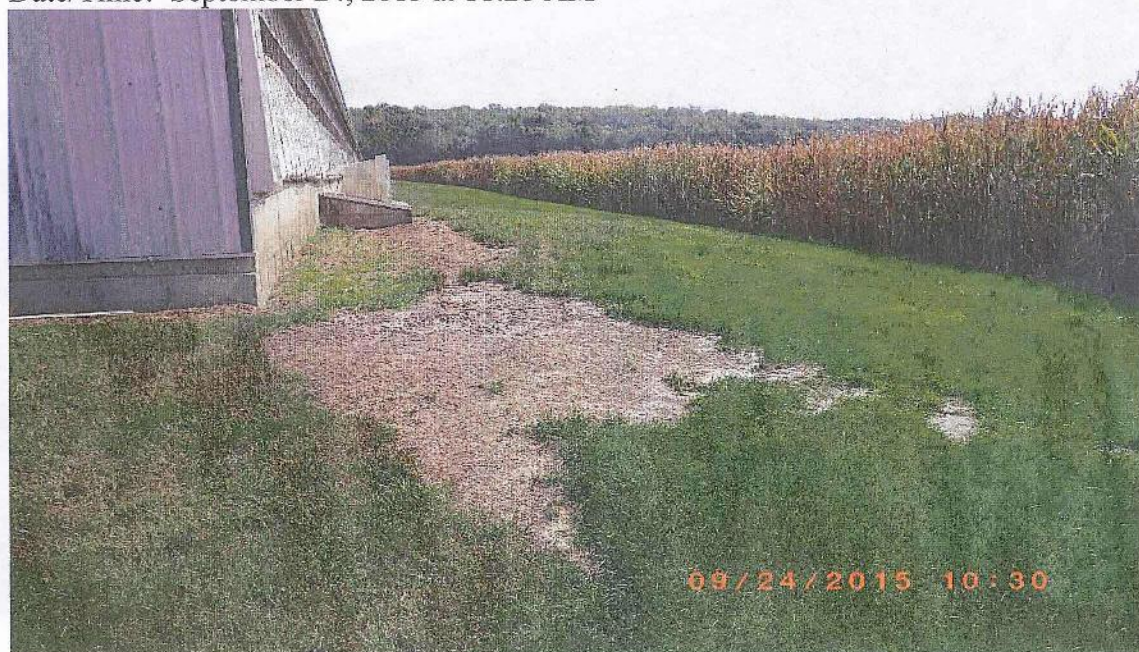
Photo: RIMG0197

Description: Denuded vegetation on the southwest corner of the southern barn.

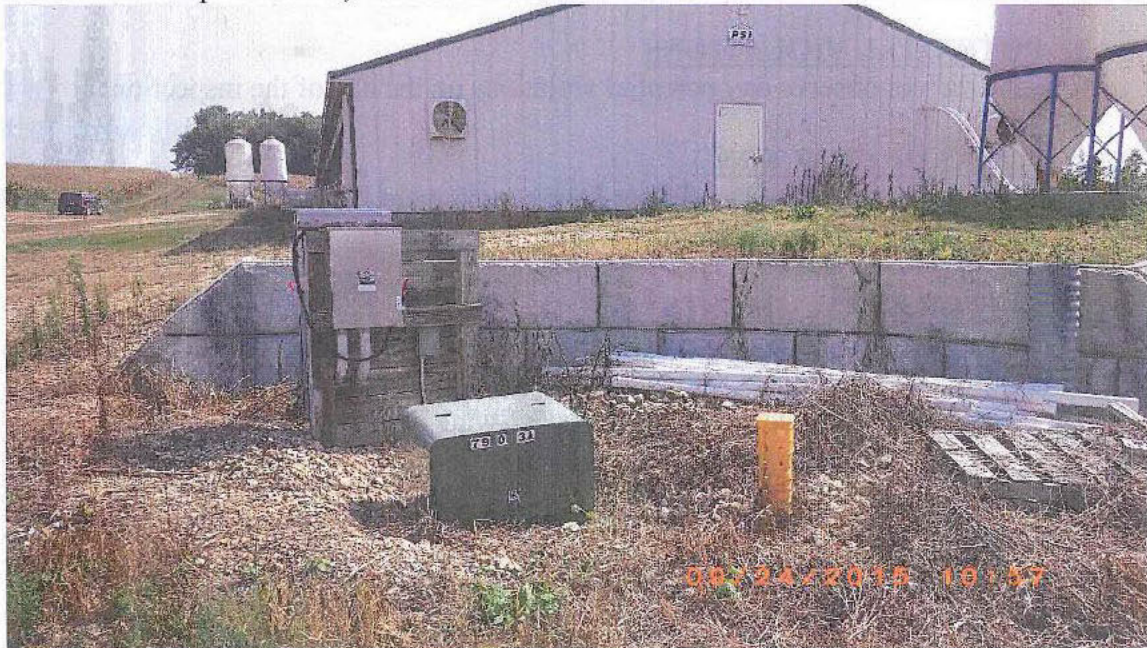
Photo: RIMG201

Description: West side of Ex. 6 (Personal Privacy) electrical box and stand pipe to drain storm water.

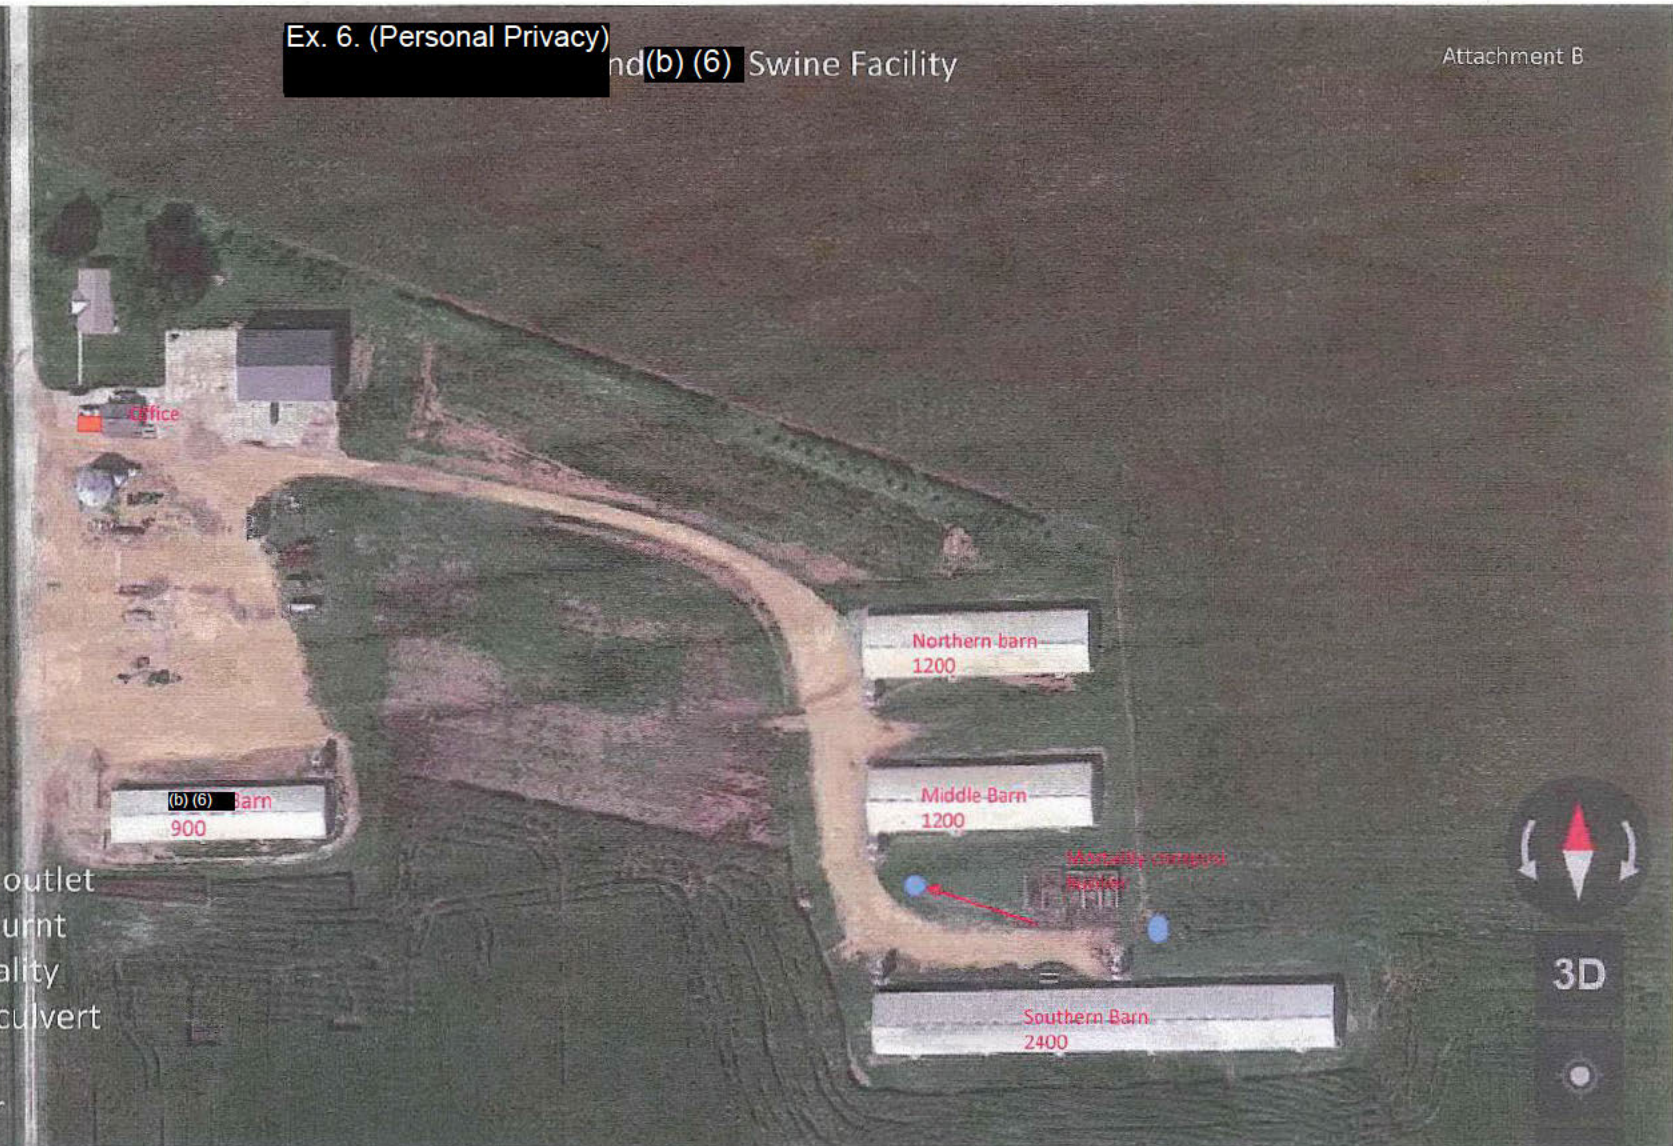
Attachment B

- Culvert Inlet and outlet
- ← Denuded and burnt pathway from mortality compost bunker to culvert inlet.
- Government car
